MiVoice Business Voice Quality Troubleshooting Guide

Release 10.1 Document Version 1.0

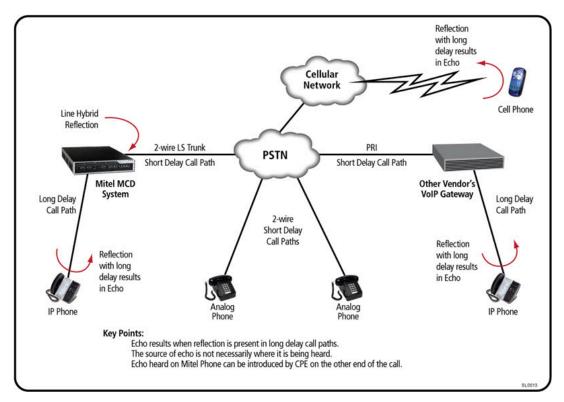
Figure 2: Electrical Echo Origin

It is important to note that the source of echo is not necessarily where it is being heard. Echo that originates in the CPE on one side of the PSTN might be heard in the CPE on the other end. You must educate your customer so that they understand that although echo is being heard on a Mitel phone, the echo may in fact originate in another vendor's CPE on the other side of the PSTN.

Electrical Echo Origin illustrates how echo can originate in CPE on either site of the PSTN:

Echo in CPE can also be caused by reflections that originate in the Central Office Equipment of the Telco. Typically, reflection on the PSTN does not result in echo on PSTN calls because the call delay is usually too short. PSTN calls are normally transmitted via copper wire, optical cable, and microwave and the speed at which these signals travel is close to the speed of light (about one foot per nanosecond, or about five microseconds per mile). Signals over copper wire travel at about 1/4 to 1/2 the speed of light, so even for a long distance land-line phone call spanning 1,000 miles, the round trip delay will be less than 20 ms, and you do not hear echo.

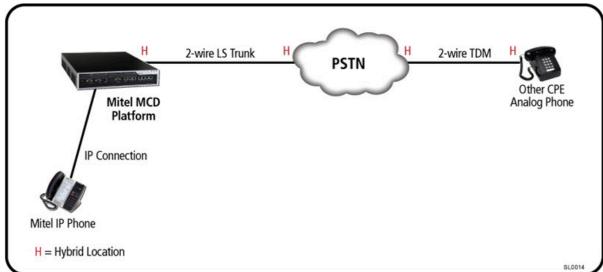
Figure 3: MiVoice IP Phone connected via IP to MiVoice Business Platform

In Scenario 1 (MiVoice IP Phone connected via IP to MiVoice Business Platform), a MiVoice IP Phone is connected via IP to the MiVoice Business platform which is connected to the PSTN via 2-wire, Loop Start (LS) trunk.

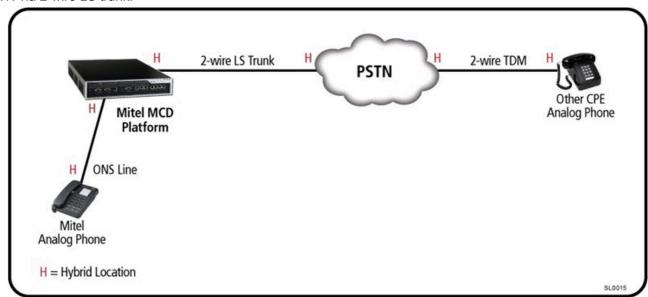
Figure 4: Analog Phone connected to MiVoice Business Platform

In scenario 2 (Analog Phone connected to MiVoice Business Platform), an analog phone is connected to the MiVoice Business platform via a 2-wire ONS line; the MiVoice Business platform is connected to the PSTN via 2-wire LS trunk.

- 2. The ONS line on the MiVoice Business platform does not introduce any significant delay that could cause echo. Therefore, you are not responsible for cancelling reflections from entering the PSTN for the benefit of the CPE 2-wire analog phone on the other side of the PSTN.

- **6.** There are three hybrids in the Mitel CPE that cause reflections in the direction of the PSTN 2-wire analog phone. Since the delay though the MiVoice Business system is short, these three reflections cannot be distinguished from a single reflection and can be handled by the PSTN as if they originated from a single two-wire phone hybrid.

- 7. The 2-wire analog phone may generate acoustic, mechanical, or crosstalk reflections. Normally the levels of these reflections are much lower than the hybrid reflection, with approximately the same delay, so no acoustic echo canceller or suppressor is needed. However, if the 2-wire set has a handsfree mode, echo suppression will be needed because of the louder levels and the additional delays caused by longer acoustic echo paths.

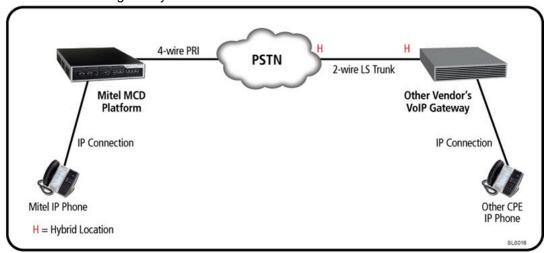
Figure 5: MiVoice Business platform connected to the PSTN via PRI trunk

In scenario 3 (MiVoice Business platform connected to the PSTN via PRI trunk), a MiVoice IP Phone is connected via IP to the MiVoice Business platform; the MiVoice Business platform is connected to the PSTN via PRI trunk; the PSTN is connected to a VoIP Gateway via LS trunk; and a VoIP phone is connected via IP to the gateway.

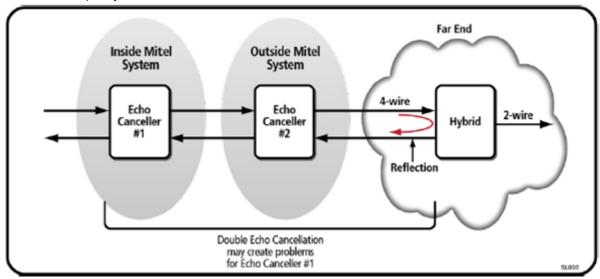
To cancel echo effectively, there should never be more than one echo canceller in each direction. However, you cannot always avoid two echo cancellers in series, because the PSTN will sometimes use echo cancellation, and there is no way to determine when this occurs.

In Figure 7: Two or More Echo Cancellers on page 23, if echo canceller #2 is functioning correctly, echo canceller #1 will never have a chance to adapt and there will be little impact on audio quality. However, if echo canceller #2 sometimes allows echo to pass, the echo canceller #1 will try to adapt. This scenario could cause voice quality issues.

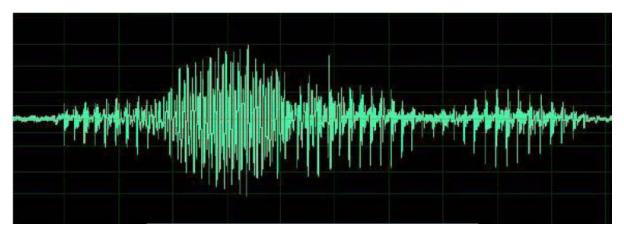
Figure 8: Normal Audio Sample

We have experienced a few cases where people with a loud, deep voice believe that they are hearing echo. Echo cancellers work by analyzing linear signals to eliminate echo. If the audio signal becomes saturated, non-linearities can result, and the echo canceller will not be able to completely cancel the echo. This results in a scratchy, distorted signal when the person is talking. This situation can happen if the speaker has a loud, deep voice that saturates the signal. Users will often report saturated audio as echo. See Normal Audio Sample and Saturated Audio Sample for examples of normal and saturated audio.

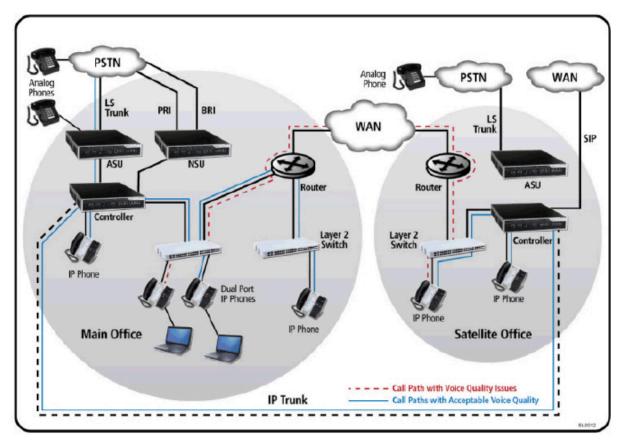
Figure 11: Example of Isolating Voice Quality Issue

In this example, you determine that the voice quality issue occurs only on VoIP calls between IP phones located in the main office and those in the satellite office. In this case, you would focus your troubleshooting on the

- routers at the network edges
- available bandwidth and traffic occurring on the path
- controller in the satellite office.

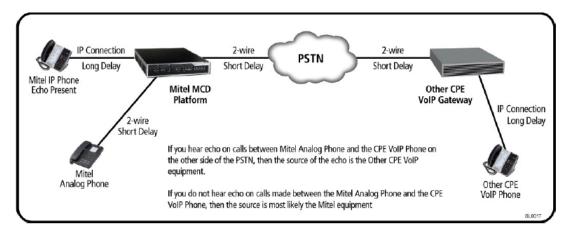
Figure 12: Identifying the Source of Echo

- If you hear echo, the customer premise equipment on the other side of the PSTN is the source. The echo must be corrected in the CPE on the other side of the PSTN.
- If you do not hear echo when you call from a Mitel analog phone, the MiVoice Businessequipment is likely the source and the echo must be corrected in the Mitel equipment.

Identifying the Source of Echo illustrates these two possibilities:
