# MiVoice Business

Troubleshooting Guide

RELEASE 9.3

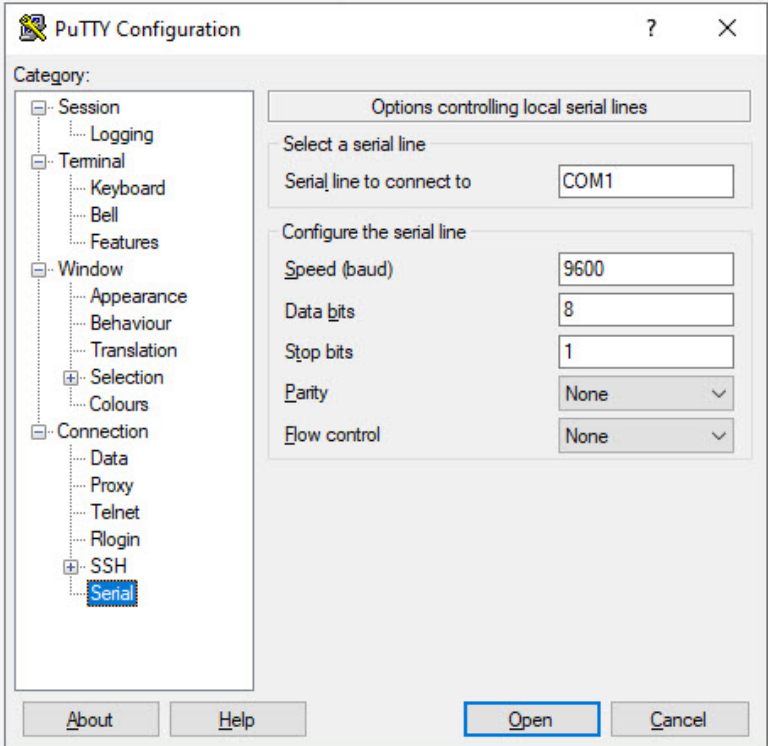
Symptom	Probable Cause	Corrective Action
The serial port on the 3300 ICP controller is unresponsive while trying to access it using a terminal emulator application.	<ul style="list-style-type: none"> <li>Configuration issue with the terminal emulator application.</li> <li>Configuration issue with the terminal server, if the serial port is connected to the terminal server (for example LanTronix-SLC32).</li> <li>Hardware issue.</li> </ul>	<p>1. Ensure that the terminal emulator application connected to the controller's serial port through the DB9 serial cable is configured correctly as shown in the following figure.</p>
